# Offset Frontal Impacts into SUVs

& Corner to Corner called FLEEs.

**SEATTLE CIREN**

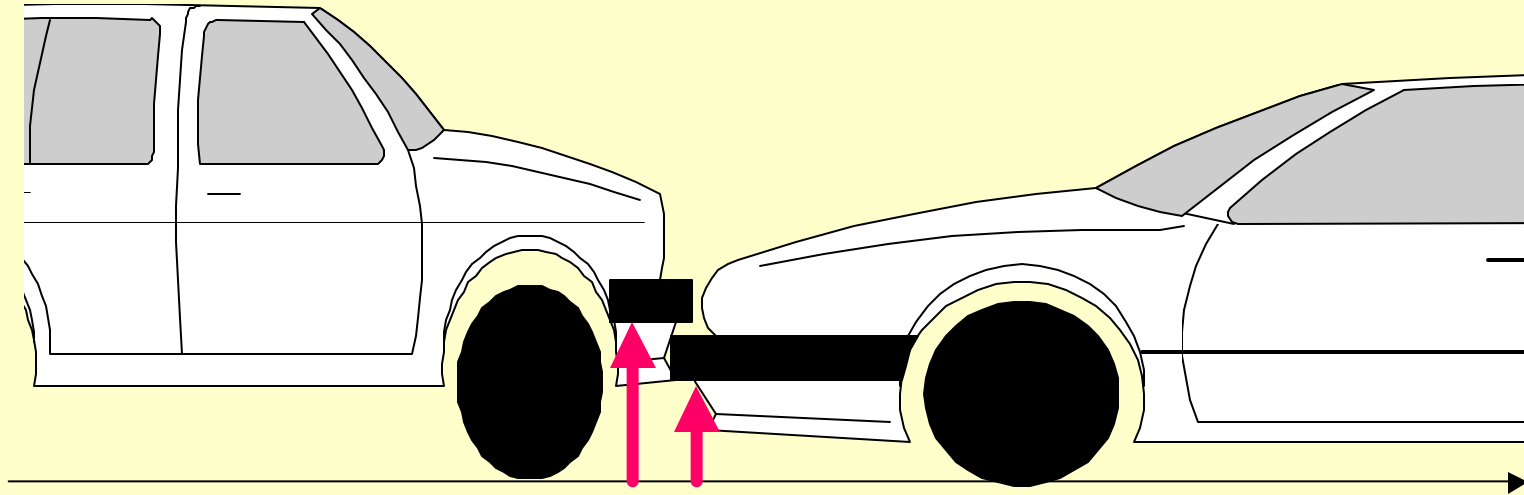
Obvious mismatch in bumper heights

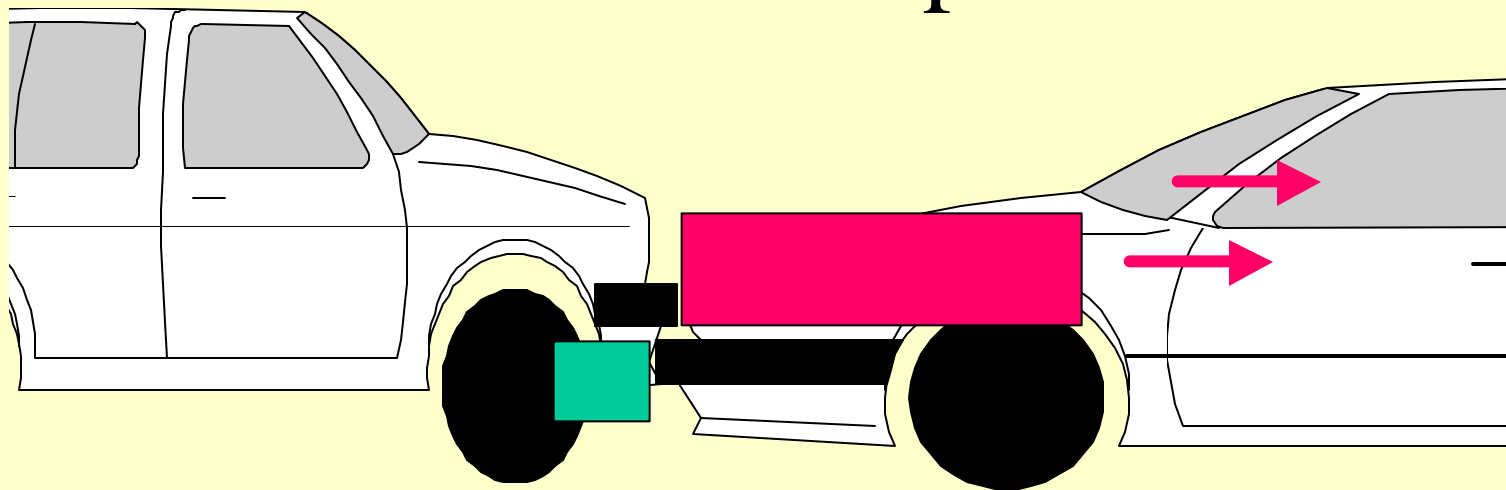
Override impact creates significant intrusion of instrument panel/hood

SUV bumper into grill of sedan

Sedan bumper into front tire/axle

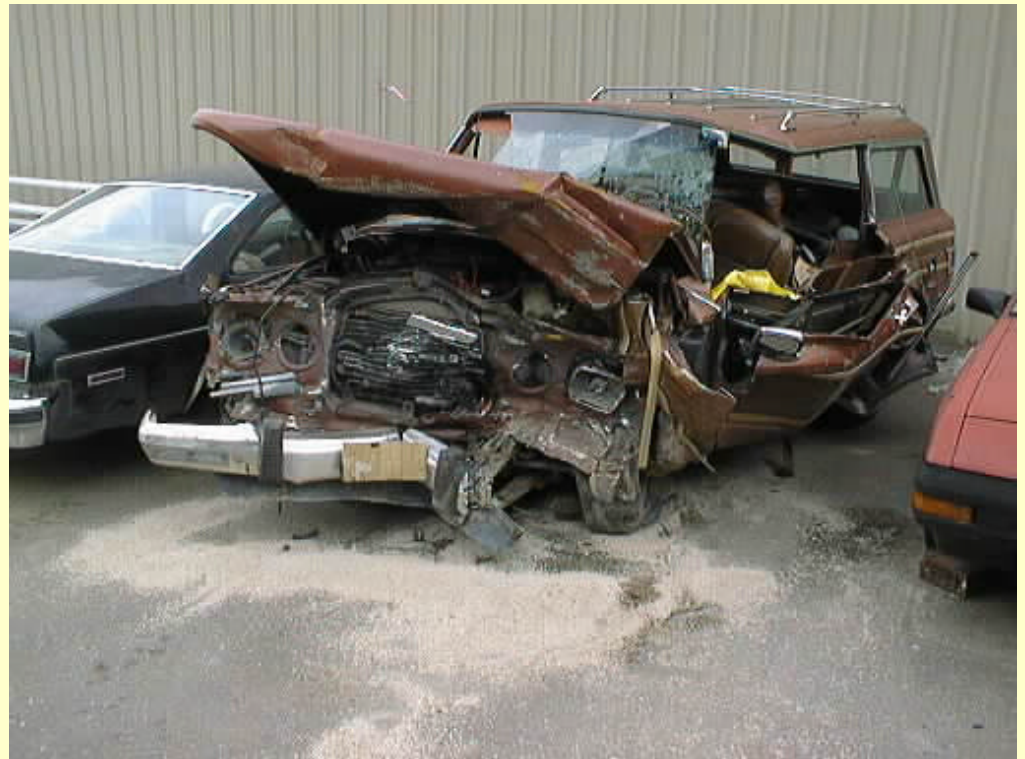
Jeep Cherokee

Delta V = 26 mph

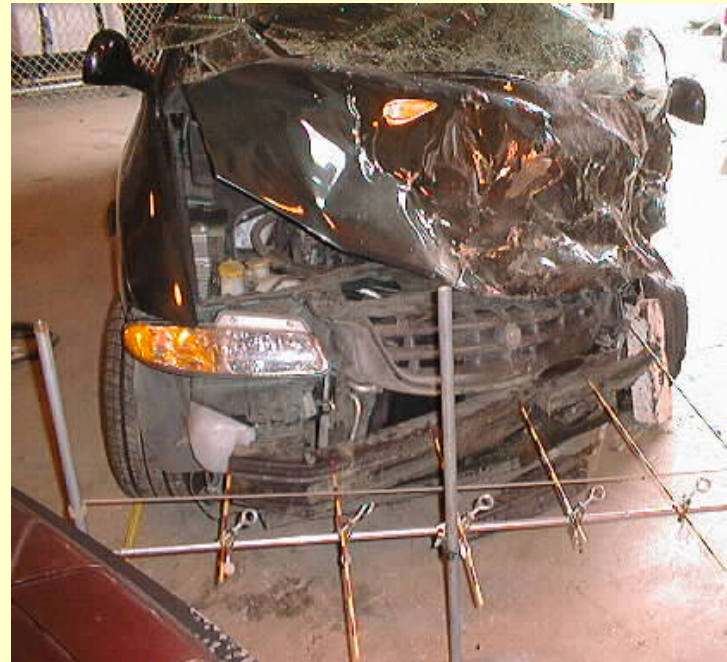
Plymouth Voyager

Delta V = 27 mph

Offset = 63%

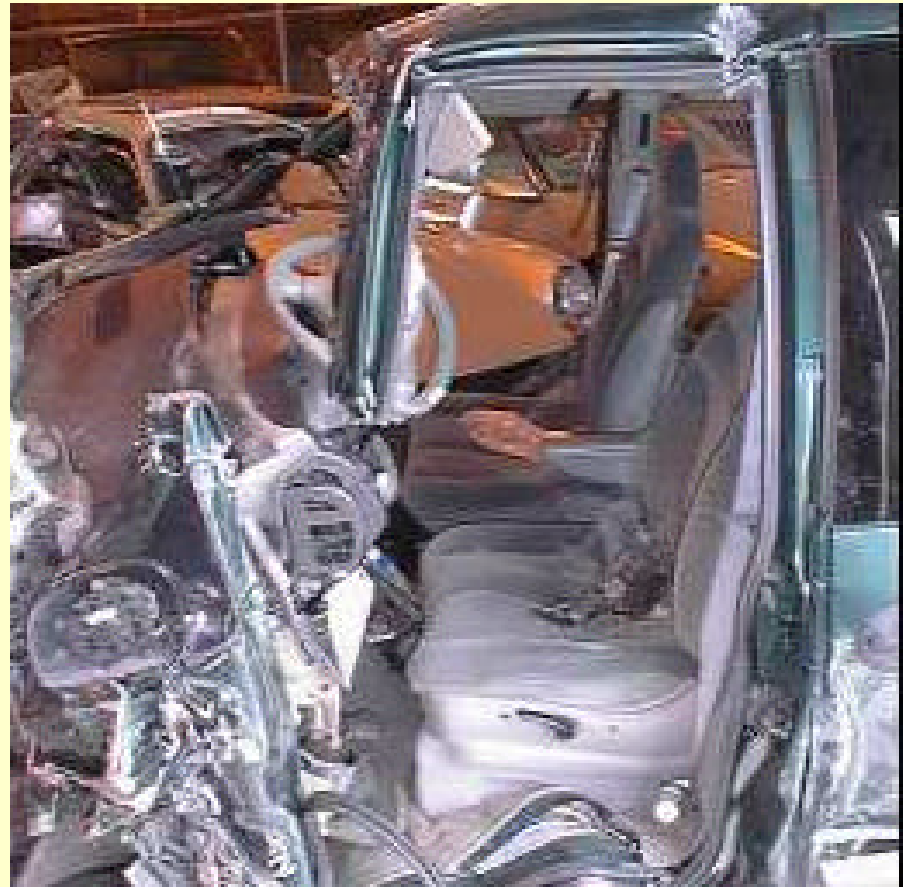
**Driver Area Intrusions**

**Toe pan = 45 cm**

**Instr.Panel = 42 cm**

**A pillar = 52 cm**

**Windshield = 24 cm**

**Kick panel = 18 cm**

**Steering col. = 15 cm**

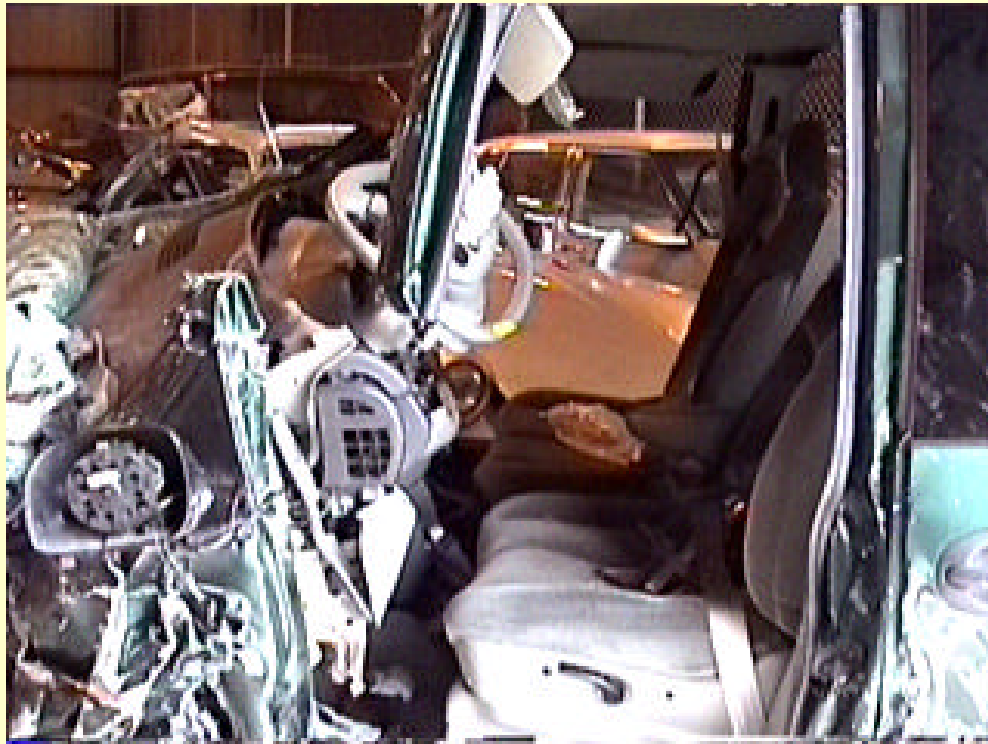
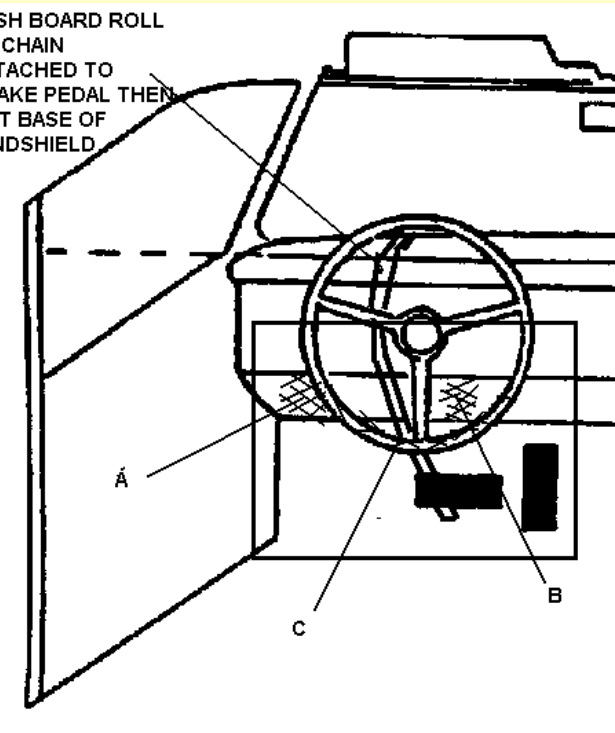
Dashboard Rollup

DASH BOARD ROLL  
UP CHAIN  
ATTACHED TO  
BRAKE PEDAL THEN  
OUT BASE OF  
WINDSHIELD

Dashboard on top of legs with both mid-shaft femurs fx'd

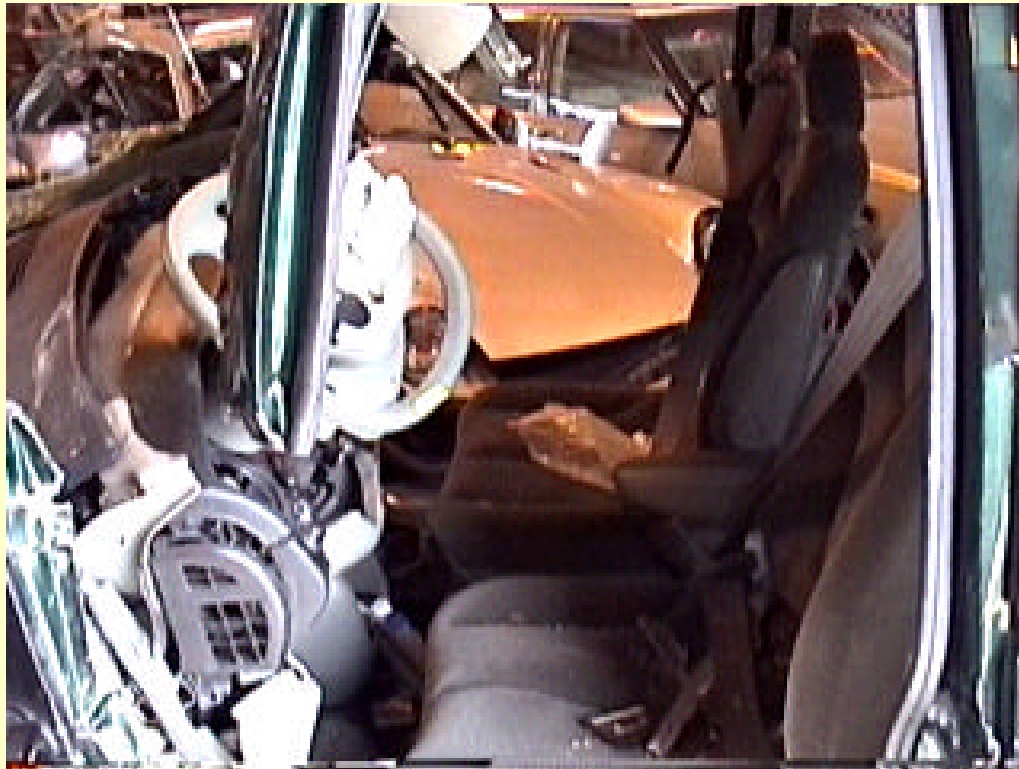
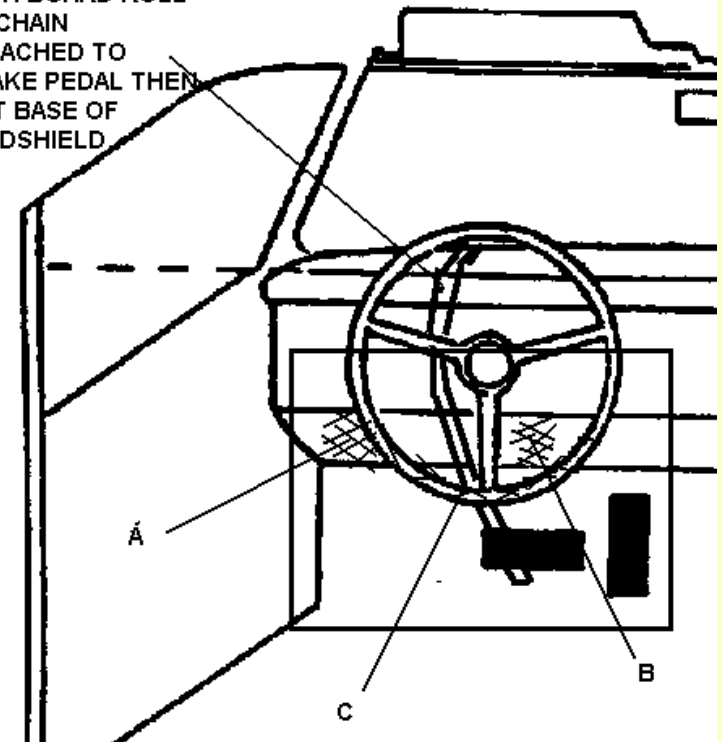
DASH BOARD ROLL  
UP CHAIN  
ATTACHED TO  
BRAKE PEDAL THEN  
OUT BASE OF  
WINDSHIELD

Both Knees contacted into bolster area

Steering Rim Deformity

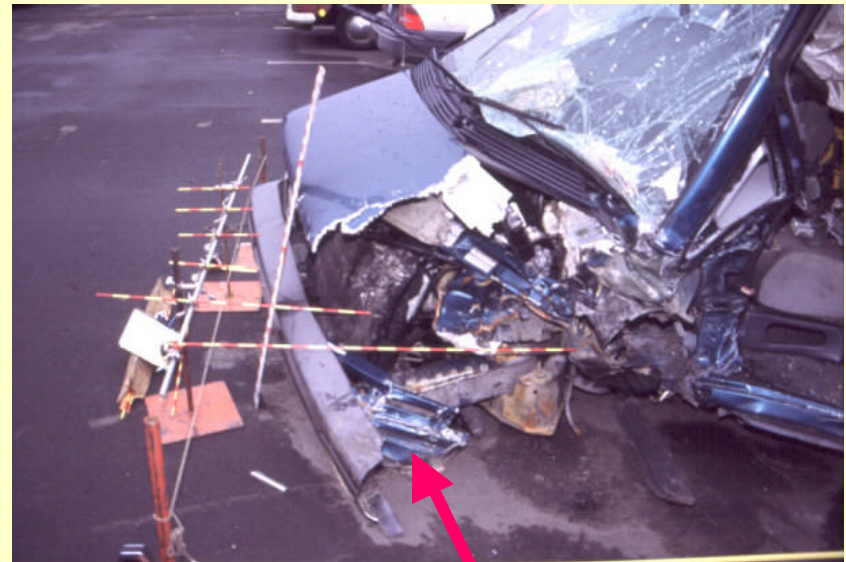
Delta V = 29 mph

Corner Impact misses frame rail

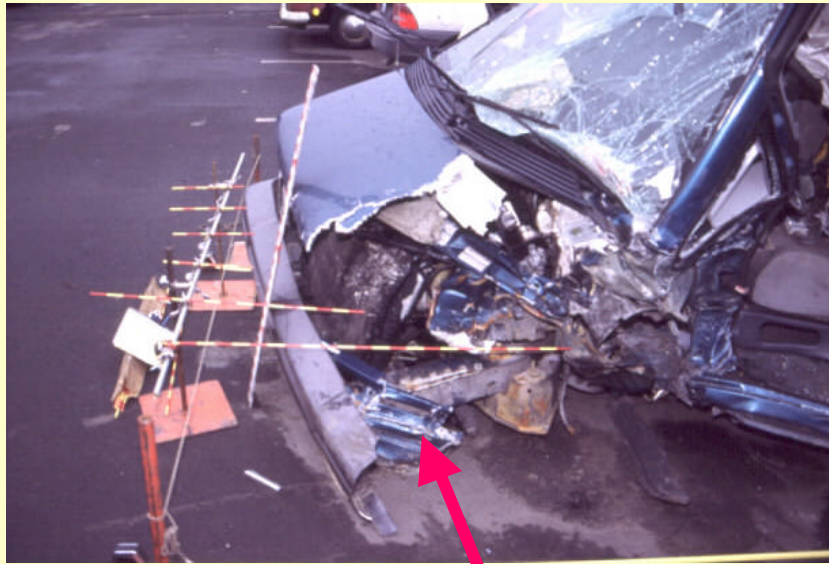
12FLEE9

**Delta V = 29 mph, 32% Offset**

Corner Impact misses frame rail

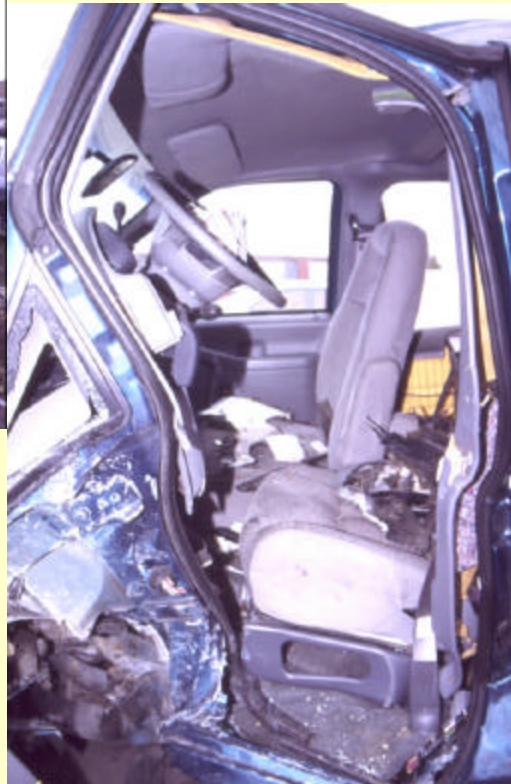
## **Driver Area Intrusion**

**Kick panel - 42 cm - Lat.**

**Instr. Panel -35 cm - Long.**

**B pillar - 32 cm - Lat.**

**Toe pan - 25 cm -Long**

**Door Panel - 25 cm - Lat.**

**A pillar - 22 cm -Long.**

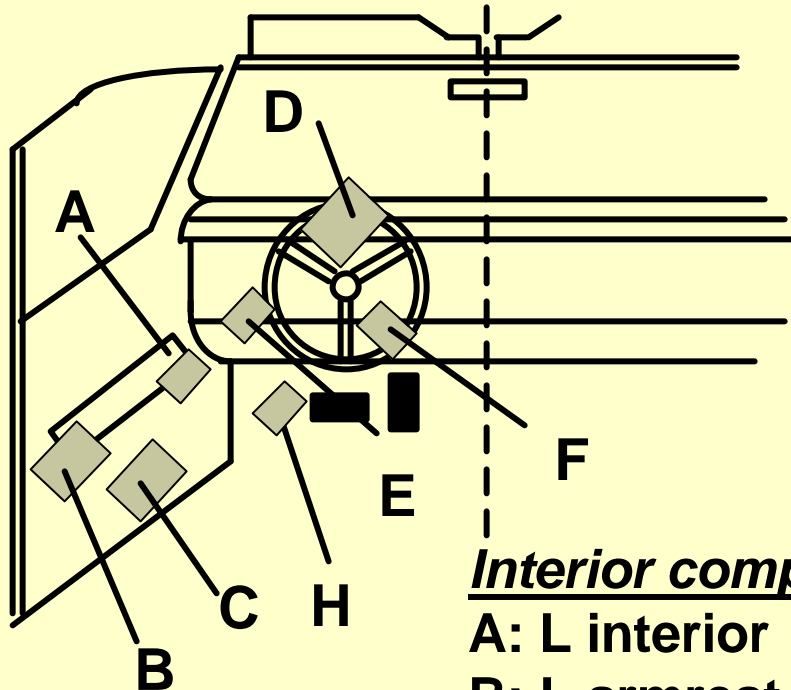
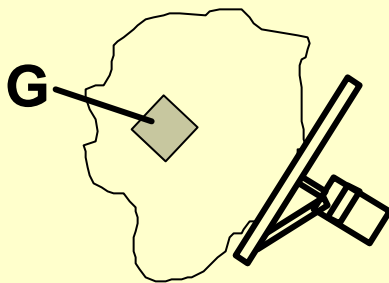
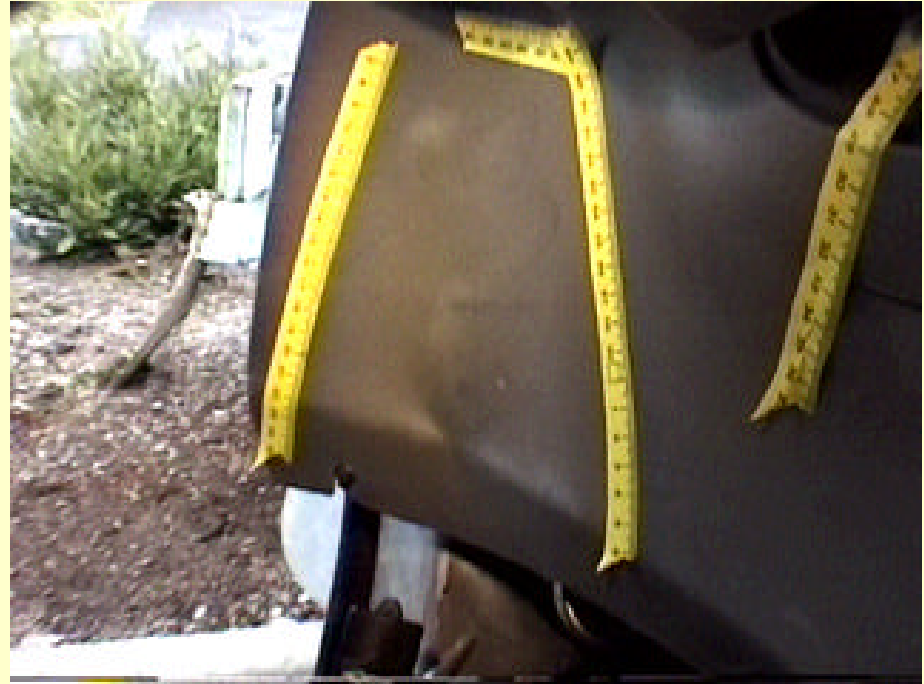
<i><b>Interior component</b></i>	<i><b>Body Region</b></i>	<i><b>Evidence</b></i>
A: L interior	L leg	Fabric transfer
B: L armrest	L hip	Fabric transfer
C: L interior	L hip	Smashed
D: Steering wheel	Chest	Deformed
E: L inst panel	L knee	Dented/ fabric
F: L inst panel	R knee	Dented/ fabric
G: Air bag	Arm	Fabric transfer
H: Kickpanel/Toe pan	L lower leg	Blood

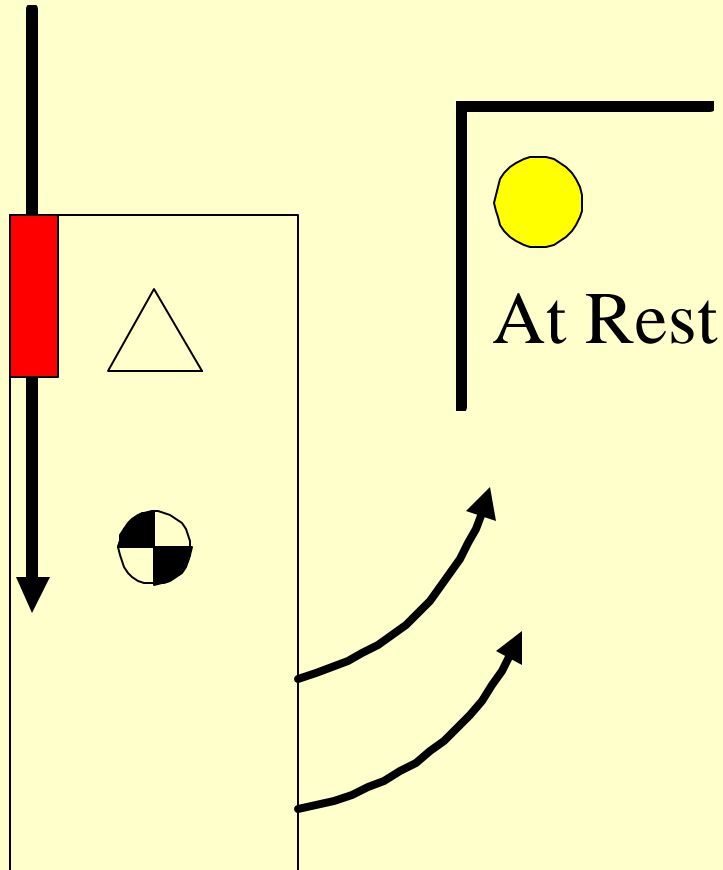
Corner impact can produce rotation of vehicle

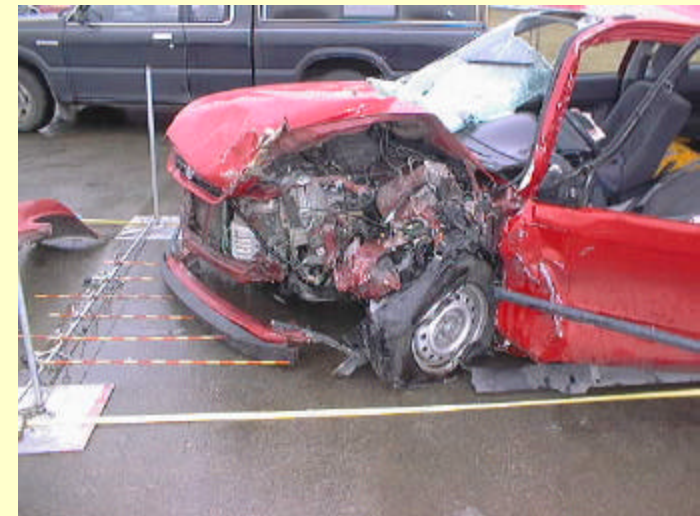
Event  
2

PDOF  
355

CDC  
12FLEE6

Delta V  
27 mph  
(Oldmiss)

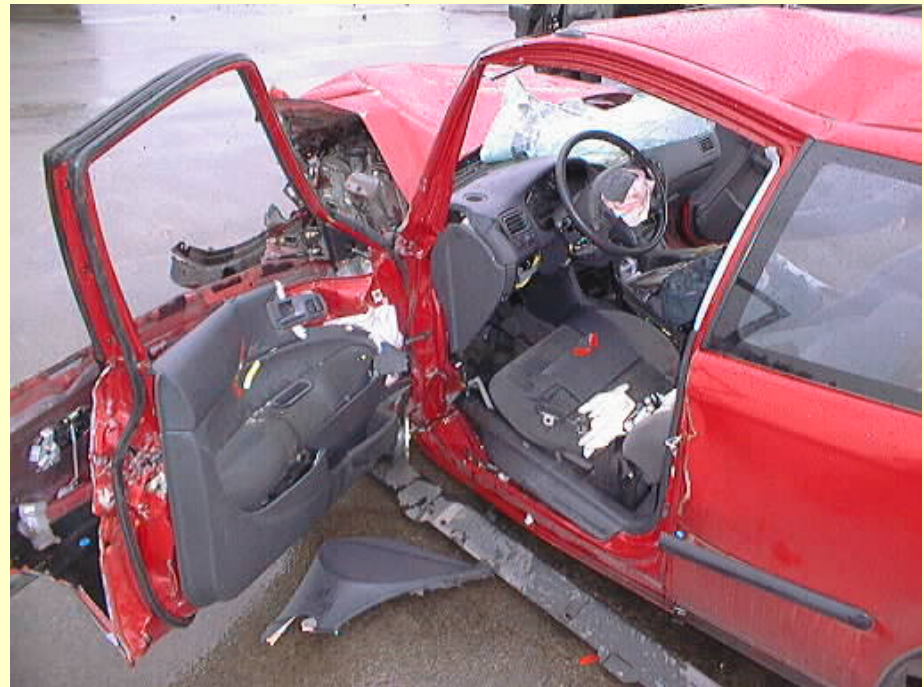
Row	Position	Area	Intruded Component	Comparator	Intruded	Intruder	Magnitude	Crush Direction
Front Seat	Left	Interior	Instrument panel left	87	64	23	>= 15 to < 30 cms	Longitudinal
Front Seat	Left	Interior	Toe pan	134	110	24	>= 15 to < 30 cms	Longitudinal
Front Seat	Left	Interior	Side panel - forward of	111	92	19	>= 15 to < 30 cms	Longitudinal
Front Seat	Left	Interior	A (A1/A2)-pillar	98	80	18	>= 15 to < 30 cms	Longitudinal
Front Seat	Left	Interior	Steering Assembly	67	55	12	>= 8 to < 15 cms	Longitudinal
Front Seat	Left	Interior	Windshield	102	90	12	>= 8 to < 15 cms	Longitudinal
Front Seat	Middle	Interior	Instrument panel center	87	82	5	>= 3 to < 8 cms	Longitudinal
Front Seat	Right	Interior	Instrument panel right	87	85	2	<= 2 cms	Longitudinal

Mainly Longitudinal

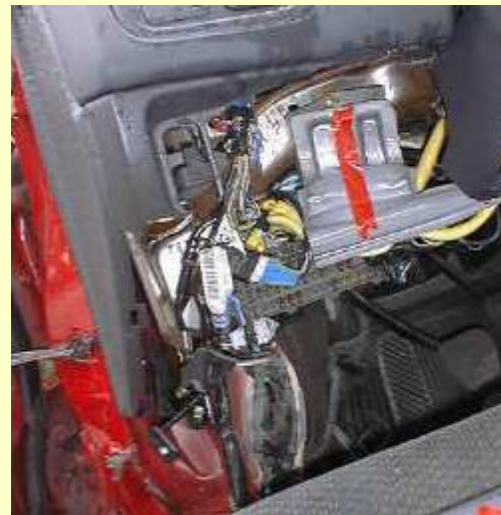
Left knee

Contact	Area	Component	Occ #	Body Region	Evidence	Confidence
A	Front	Knee bolster	1	Knee - Left	Deformed	CERTAIN
B	Front	Knee bolster	1	Knee - Right	Scuffed	CERTAIN
C	Front	Steering column,transmission sele	1	Knee - Right	Scuffed	PROBABLE
D	Left Side	Left side interior surface, excl. h	1	Elbow - Left	Deformed	PROBABLE
E	Left Side	Left A (A 1/A2)-pillar	1	Upper Arm - Left	Scratched	POSSIBLE

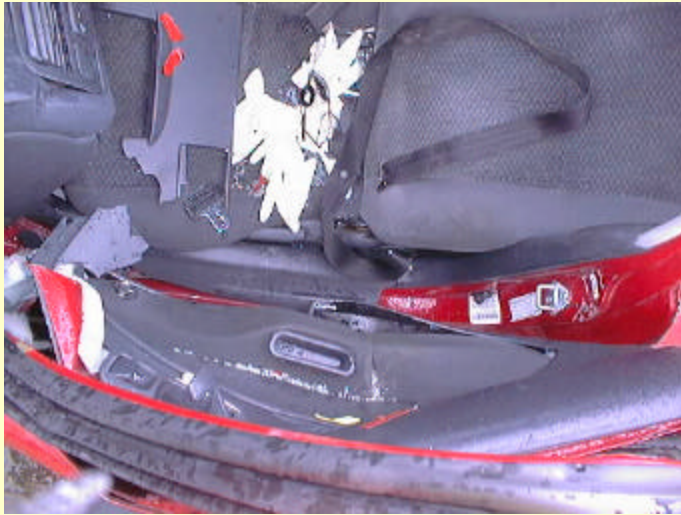
Top view - Door panel

No lateral intrusion,  
outward bowing from  
impact and possible contact

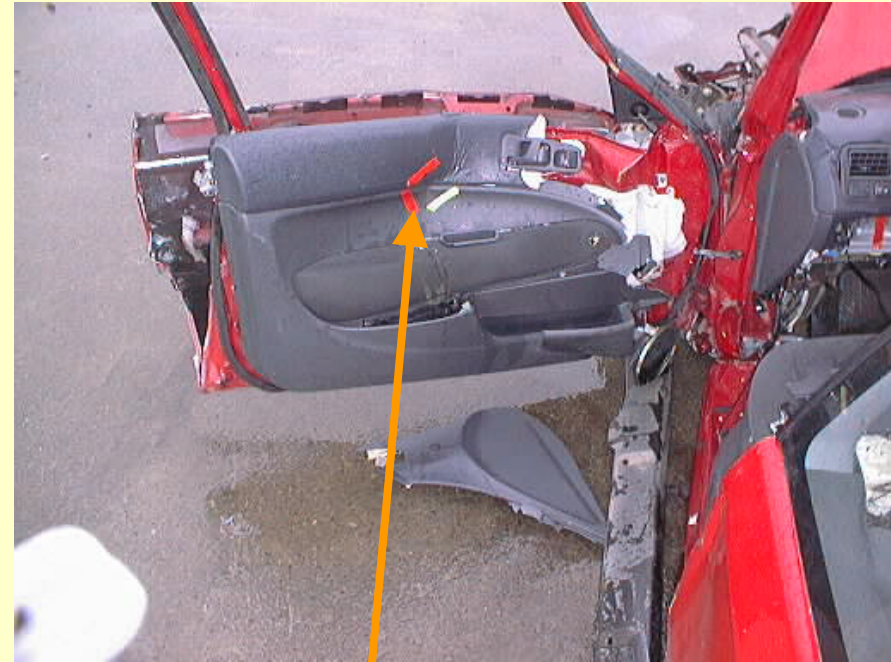
Deformation occurring  
in door panel

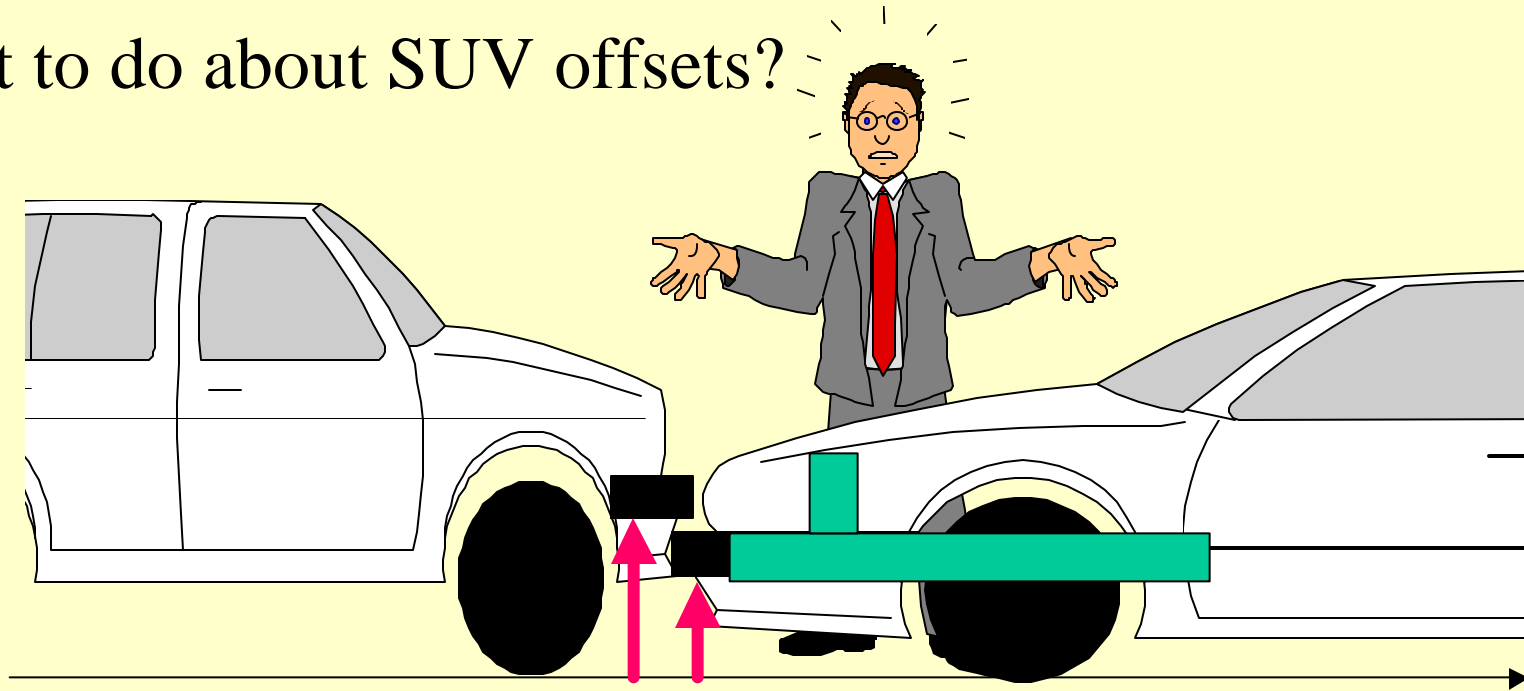
What to do about SUV offsets?

Rather than lower the support on the SUV create a vertical component on the frame rail of the sedan?

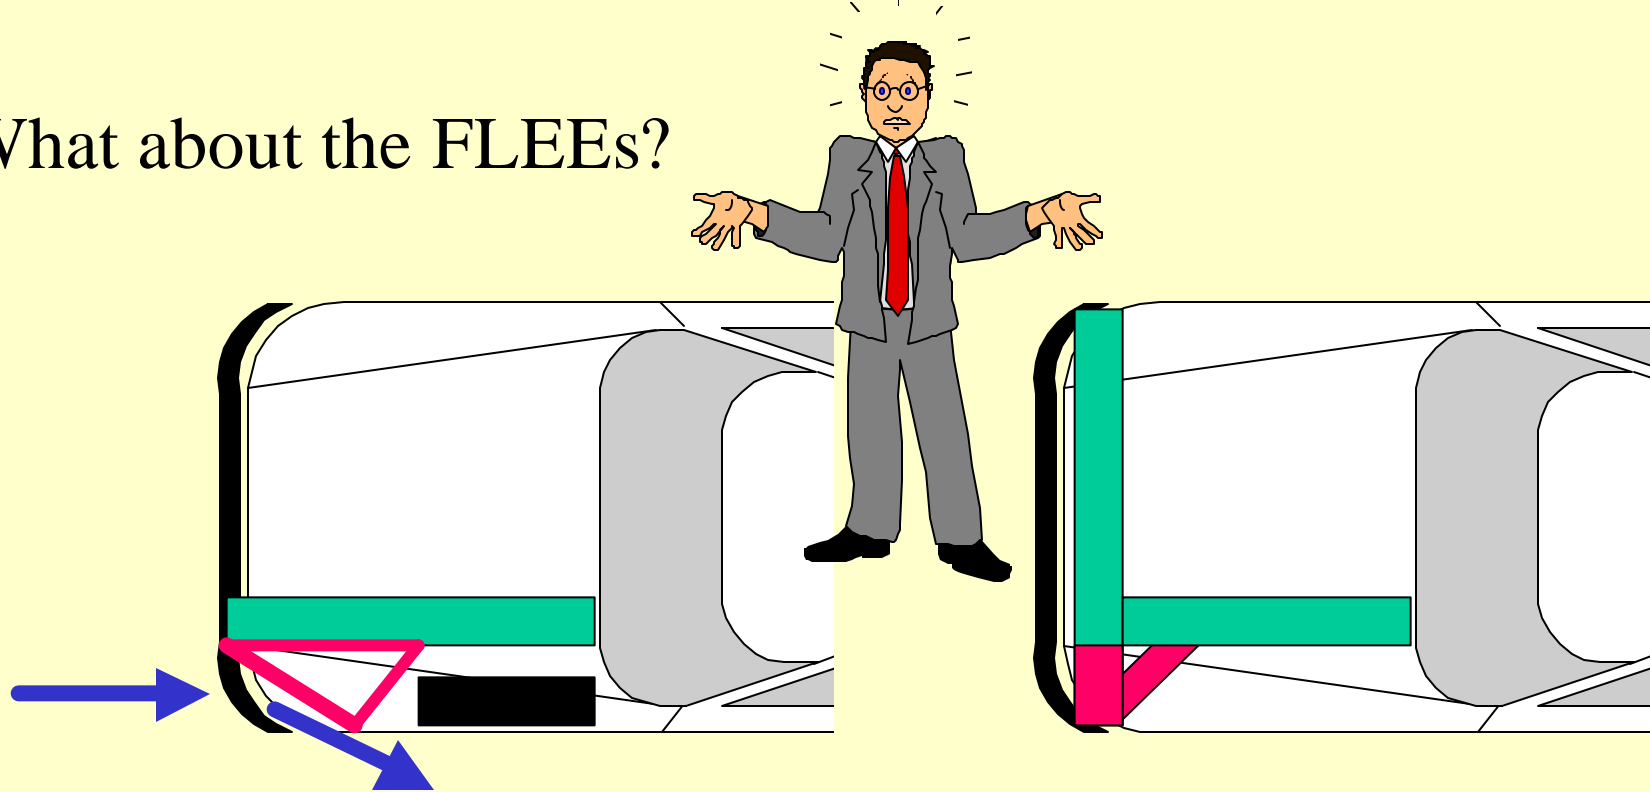
What about the FLEEs?

Need to brace and deflect the impact or  
extend the bumper support to the corner
